FINAL REPORT
9438 HIGH LEVEL TRAVELING
WAVE TUBE AMPLIFIER *ANOMALY*

VOLUME I

Prepared by
J. A. Durschinger
TRW, Inc.
TRW Defense and Space Systems Group
One Space Park
Redondo Beach, CA 90278

11 August 1978

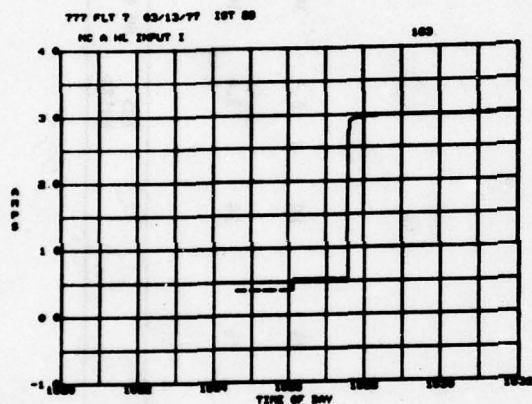
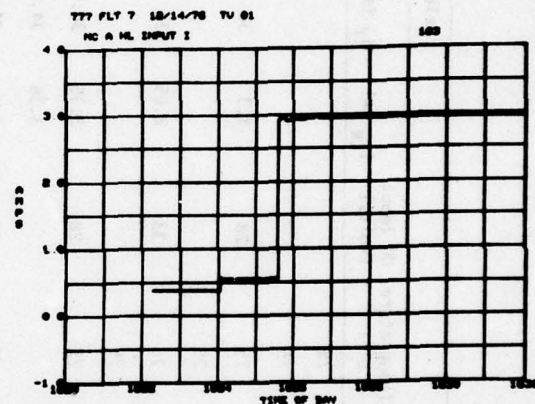
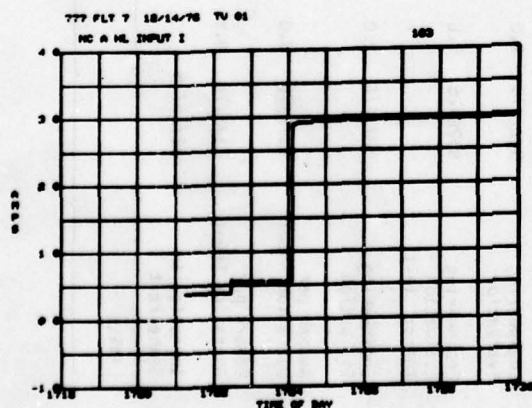
The degree of variation in input current at turn-on, as shown in the plots (Figures 3.3-1 through 3.3-4), varied considerably from amplifier to amplifier. Although F8 seemed to have more variability than the others, there were still other TWTAs which had some variability (9437 ECHLTWTA-1), for example) which appeared occasionally. The results of this data review were studied by contractor and subcontractor engineers, and no positive relationship to internal problems could be established. There was some feeling that the input current transients observed in S/N 24-17 could have been indicative of a discharge phenomenon occurring in the amplifier at initial turn-on. However, this could not be established conclusively. It was agreed that gathering of data from additional TWTAs would be useful for future study.

Figure 3.3-4. F7 NCHLTWTA-1 Input Current Characteristics Show Little Variation Between Successive Starts

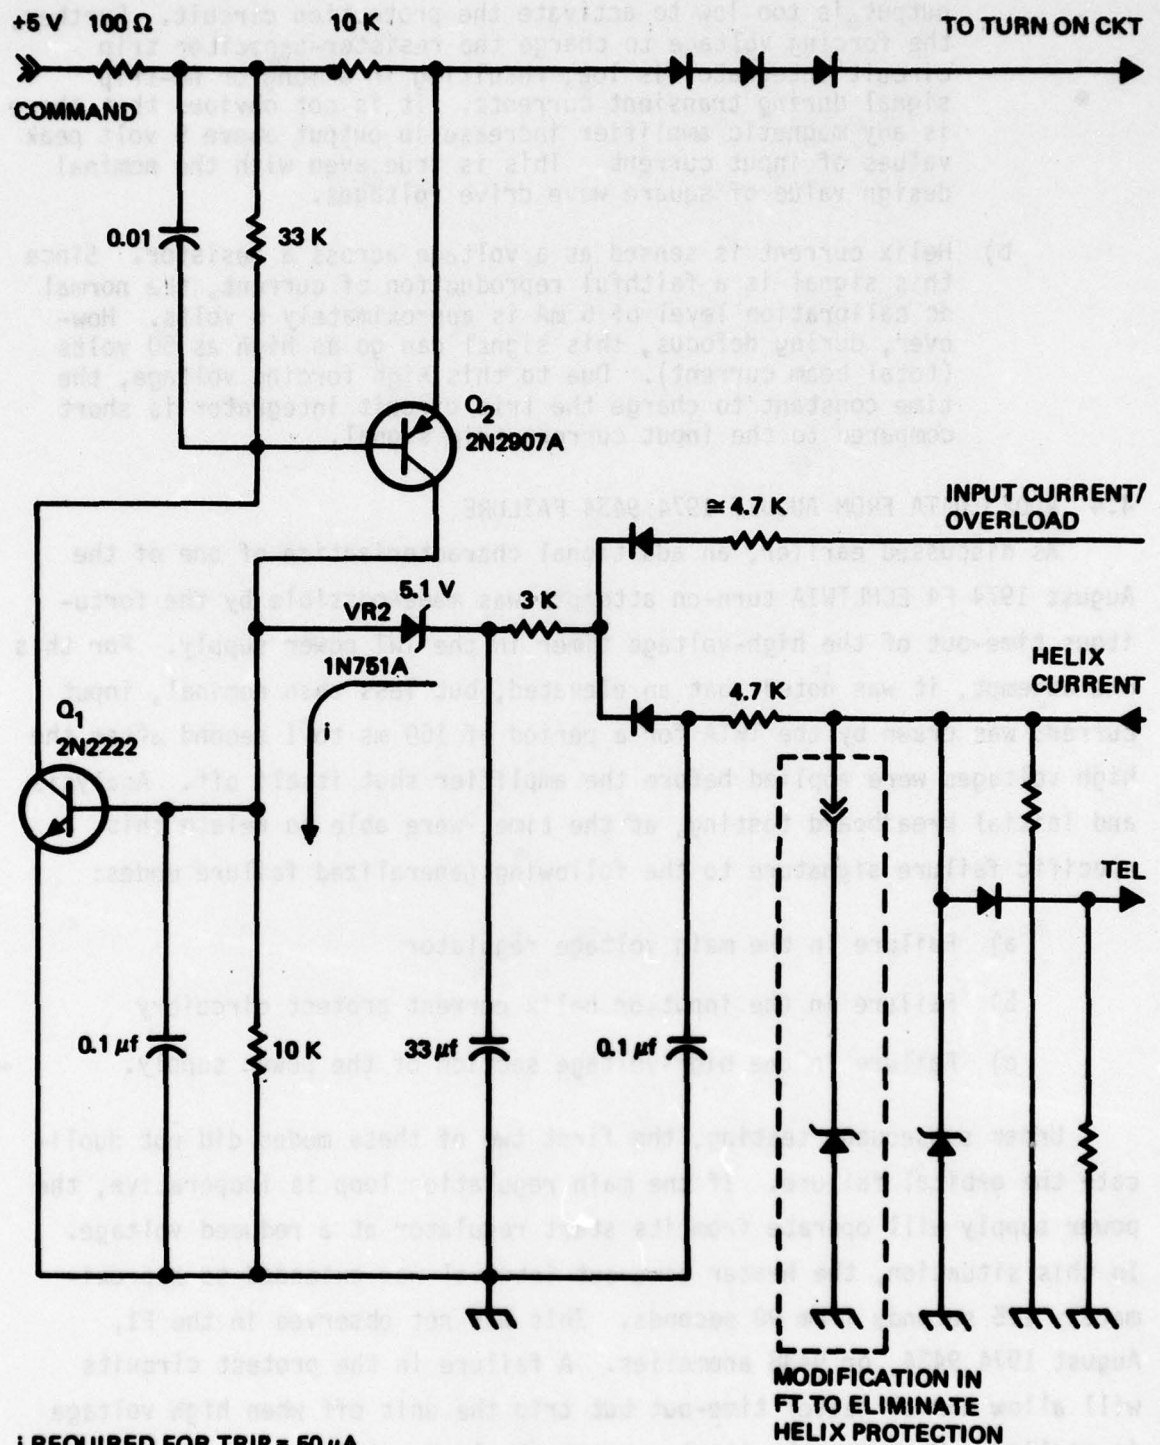
- a) Input current is sensed with a magnetic amplifier. The saturated output is very close to the calibrated trip setting (approximately 8.5 amperes) limited by the peak value of the square wave voltage exciting it. The ac square wave is derived from an inverter operating on the 19 volt bus and varies in amplitude proportional to 19 volt bus voltage. The minimum 19 volt bus voltage for operation of the current trip circuit is approximately 15 Vdc. Below this value, the magnetic amplifier

i REQUIRED FOR TRIP = $50 \mu A$
AT $0.5 V B-E Q_1$

1N751A = 5.1 V AT 20 MIN

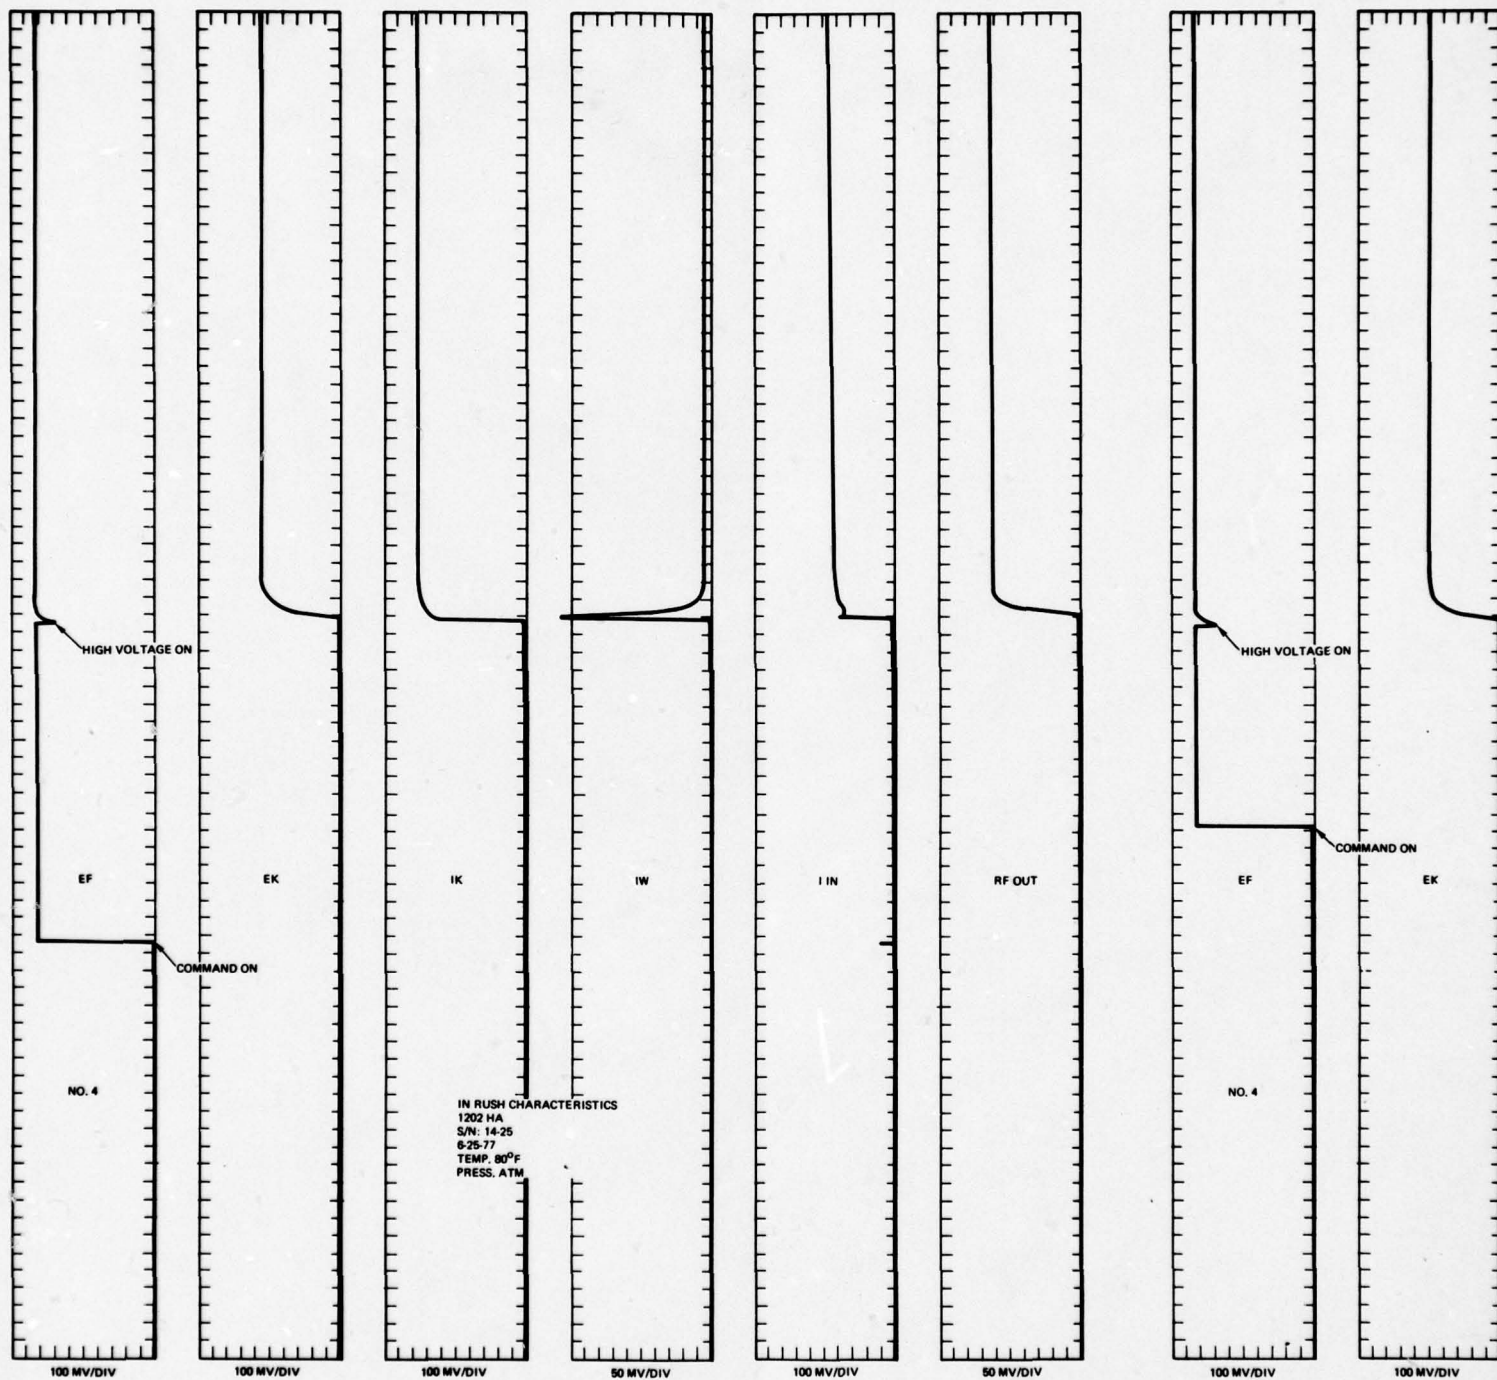
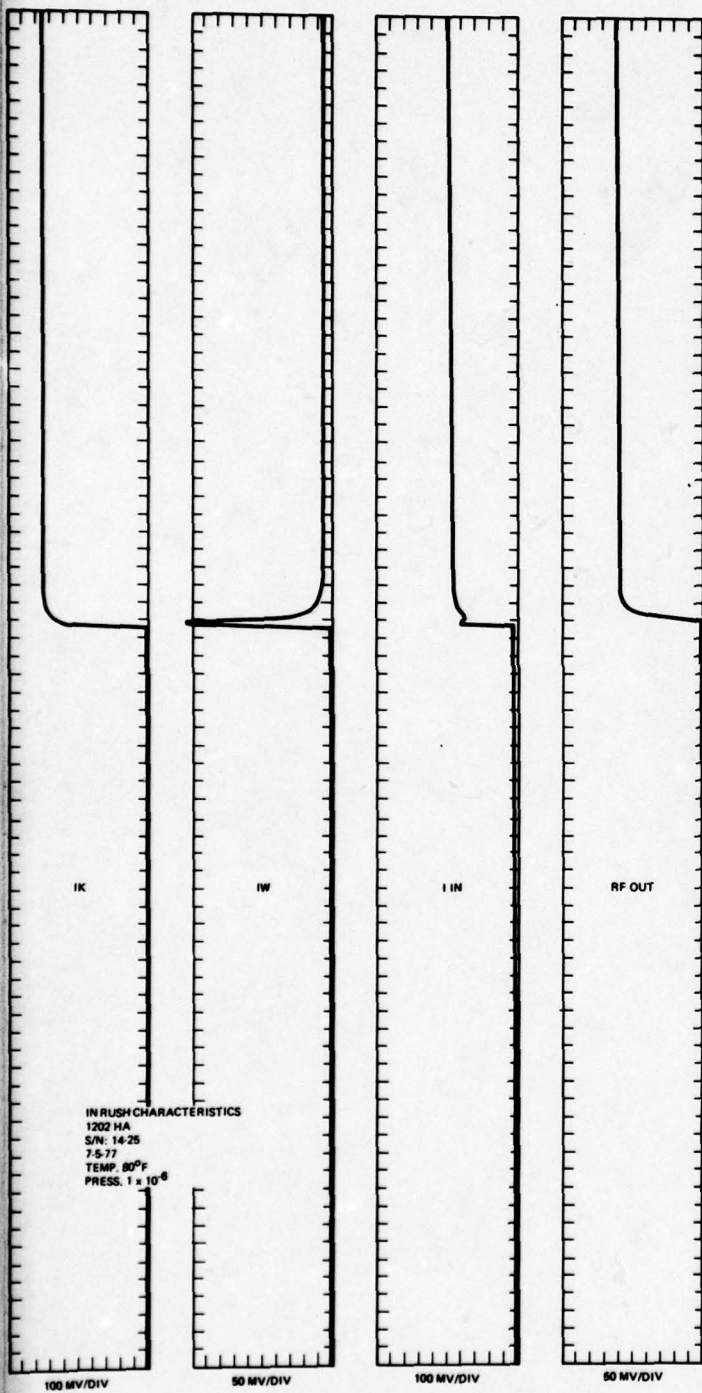
Figure 8.3-1. Turn on Characteristics for HLTWTA S/N 14-25 in Vacuum and Ambient Pressure

curves does not show any significant difference between amplifiers. Of particular interest is a comparison between S/N 14-15, the TWT which subsequently failed, and the others which did not. Again, the variation between amplifiers which survived the thermal vacuum test is greater than the variation between 14-15 and the rest. The unusual turn-on characteristic of the F8 HLTWTA-1 stands out as different. However, any attempt to explain it can be expressed in only the most speculative terms, and the short-term failure of 14-15 and 24-26, which showed nominal turn-on characteristics, precludes using these data to screen out amplifiers of short life.

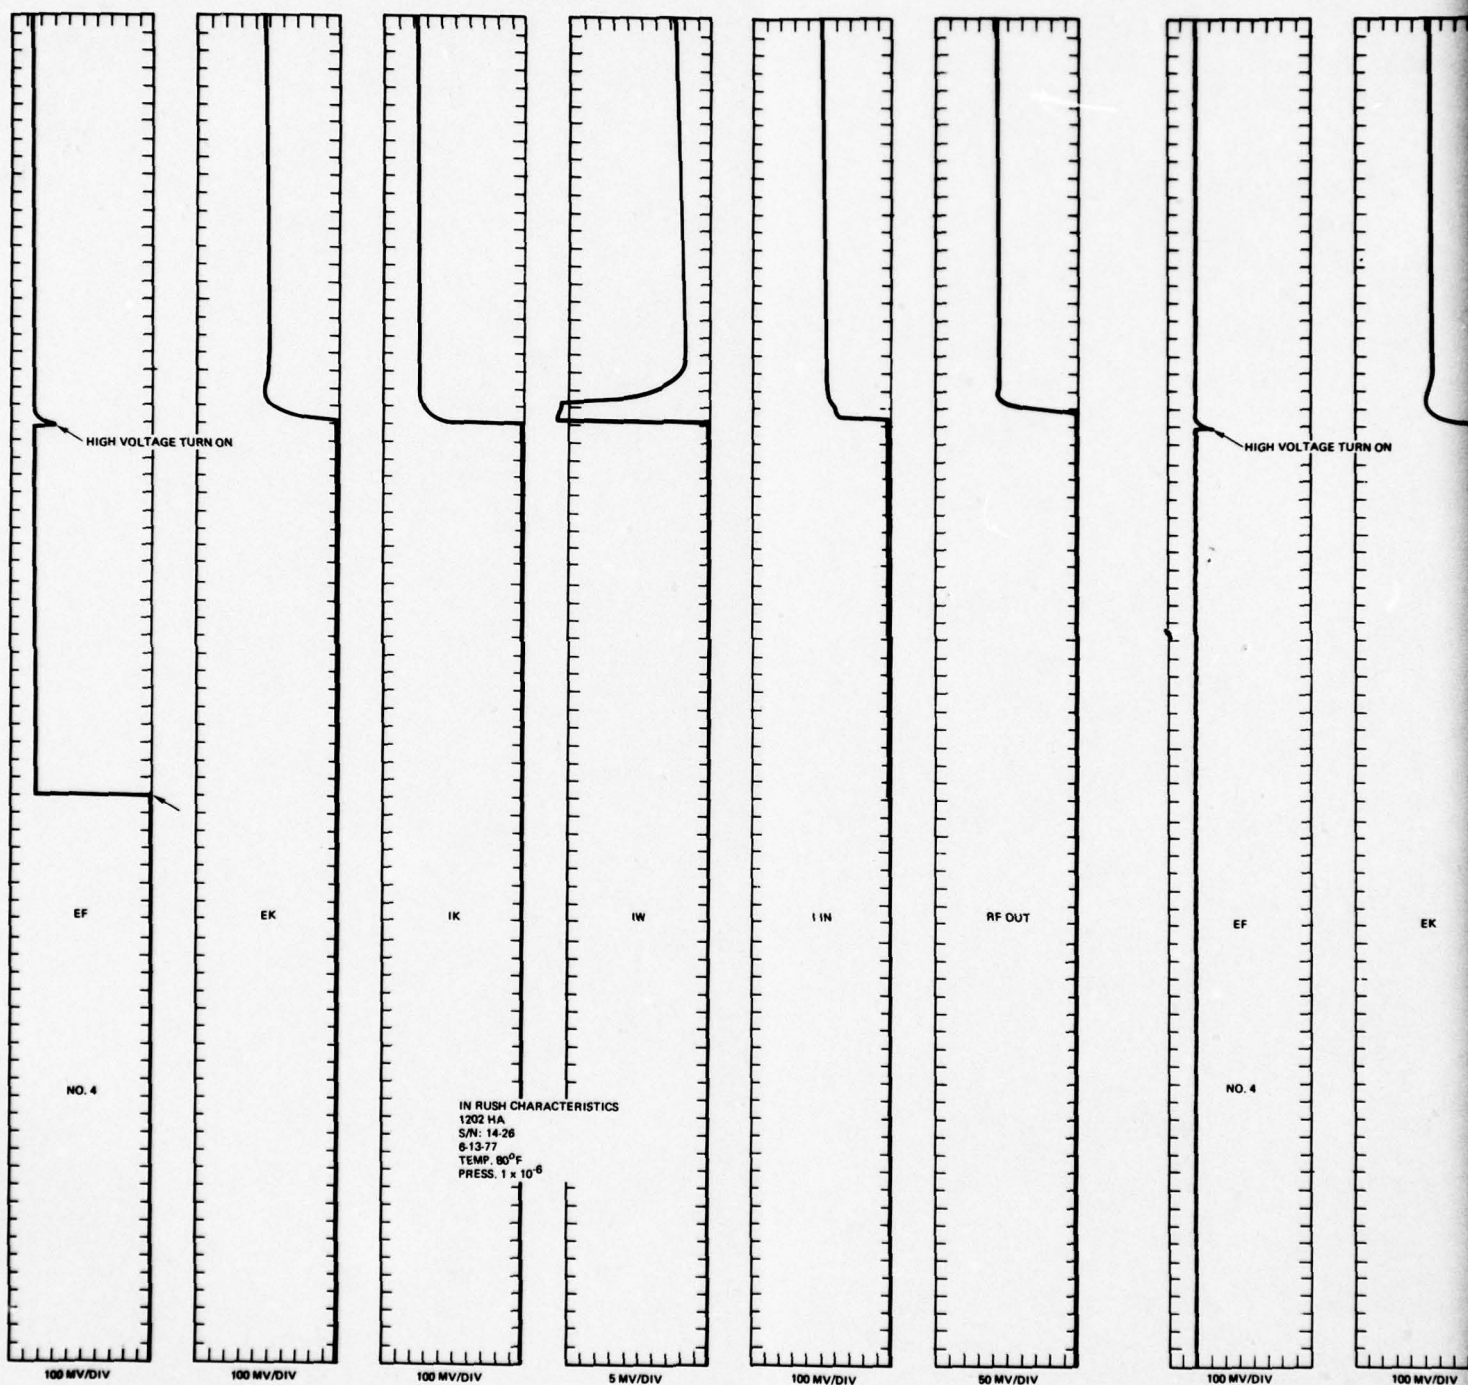
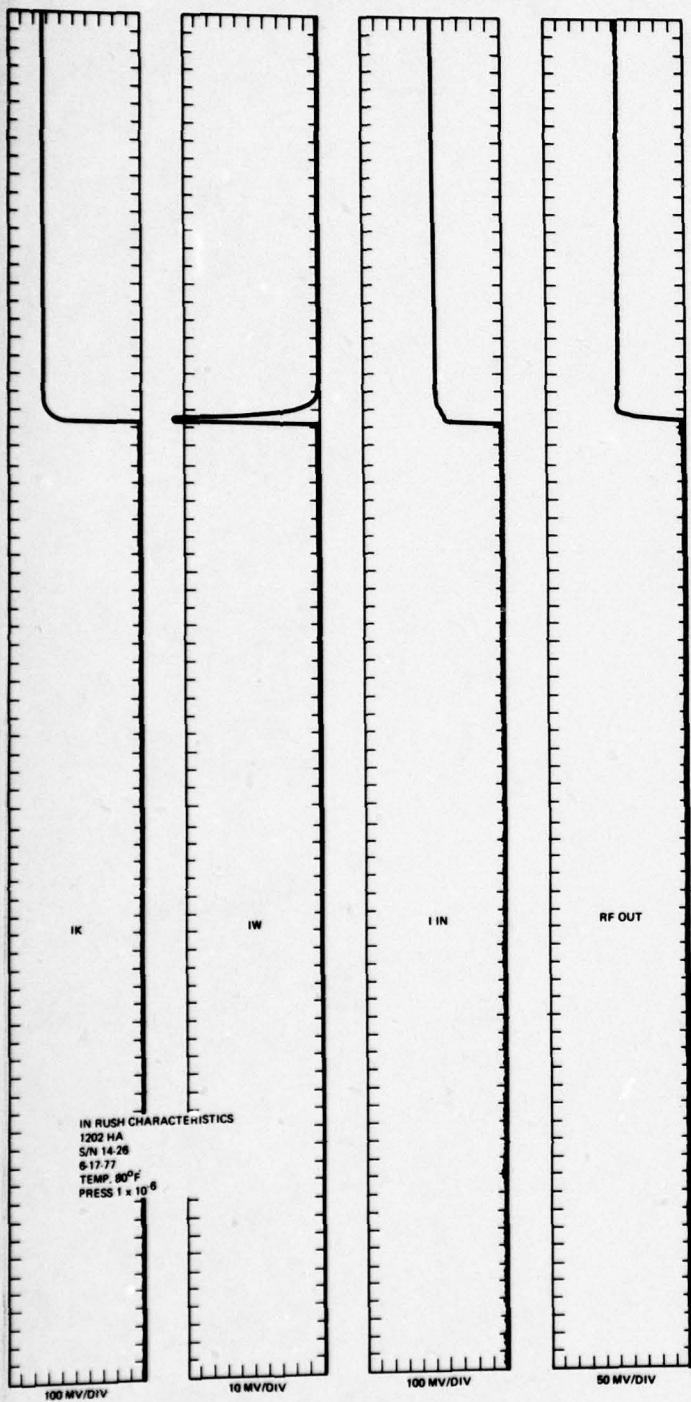
Figure 8.3-3. Turn on Characteristics for HLTWTA S/N 14-78 in Vacuum on 6/13 and 6/17/77

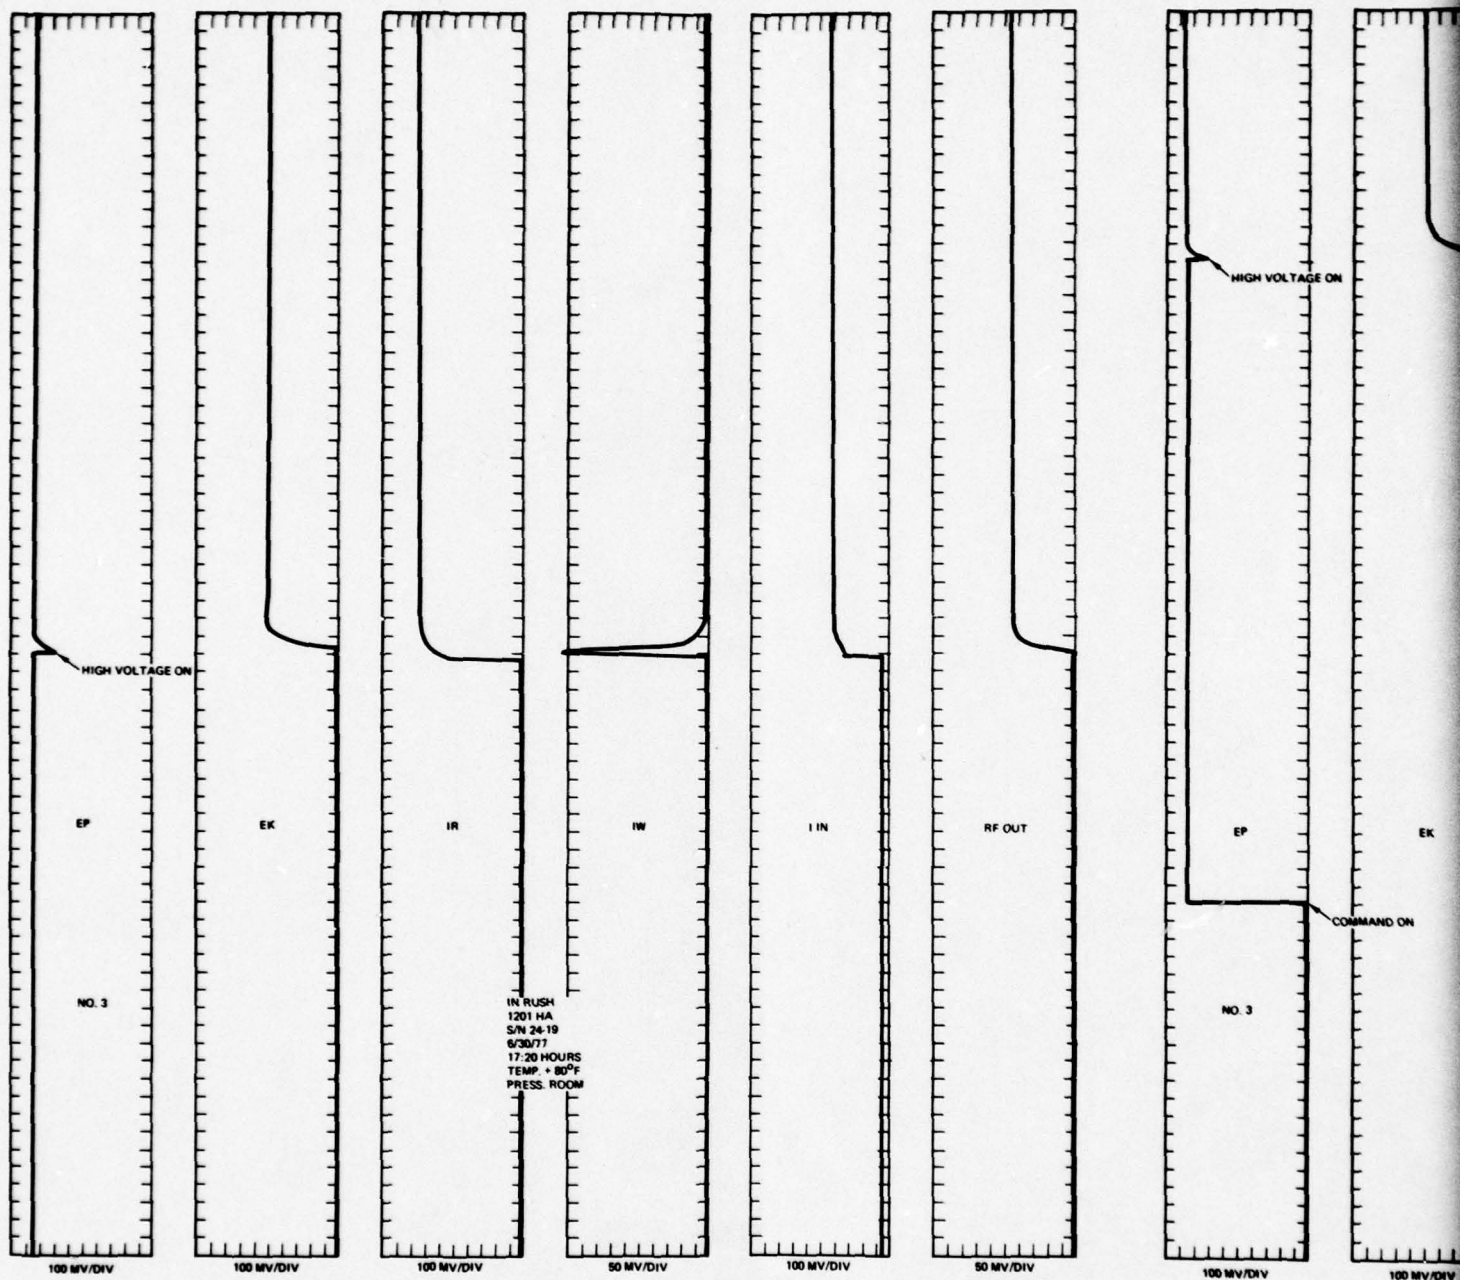
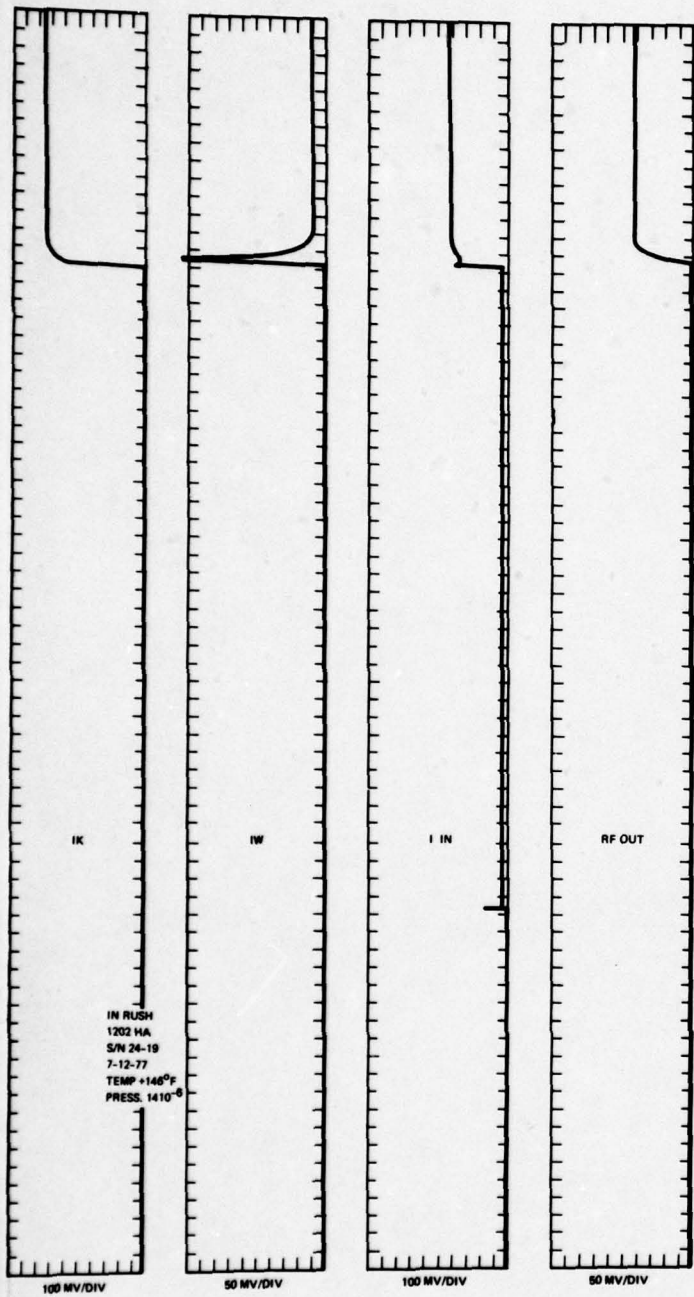
Figure B.3-4. Turn on Characteristics for MLTWT A S/N 24-19 at Vacuum and Ambient Pressure Conditions

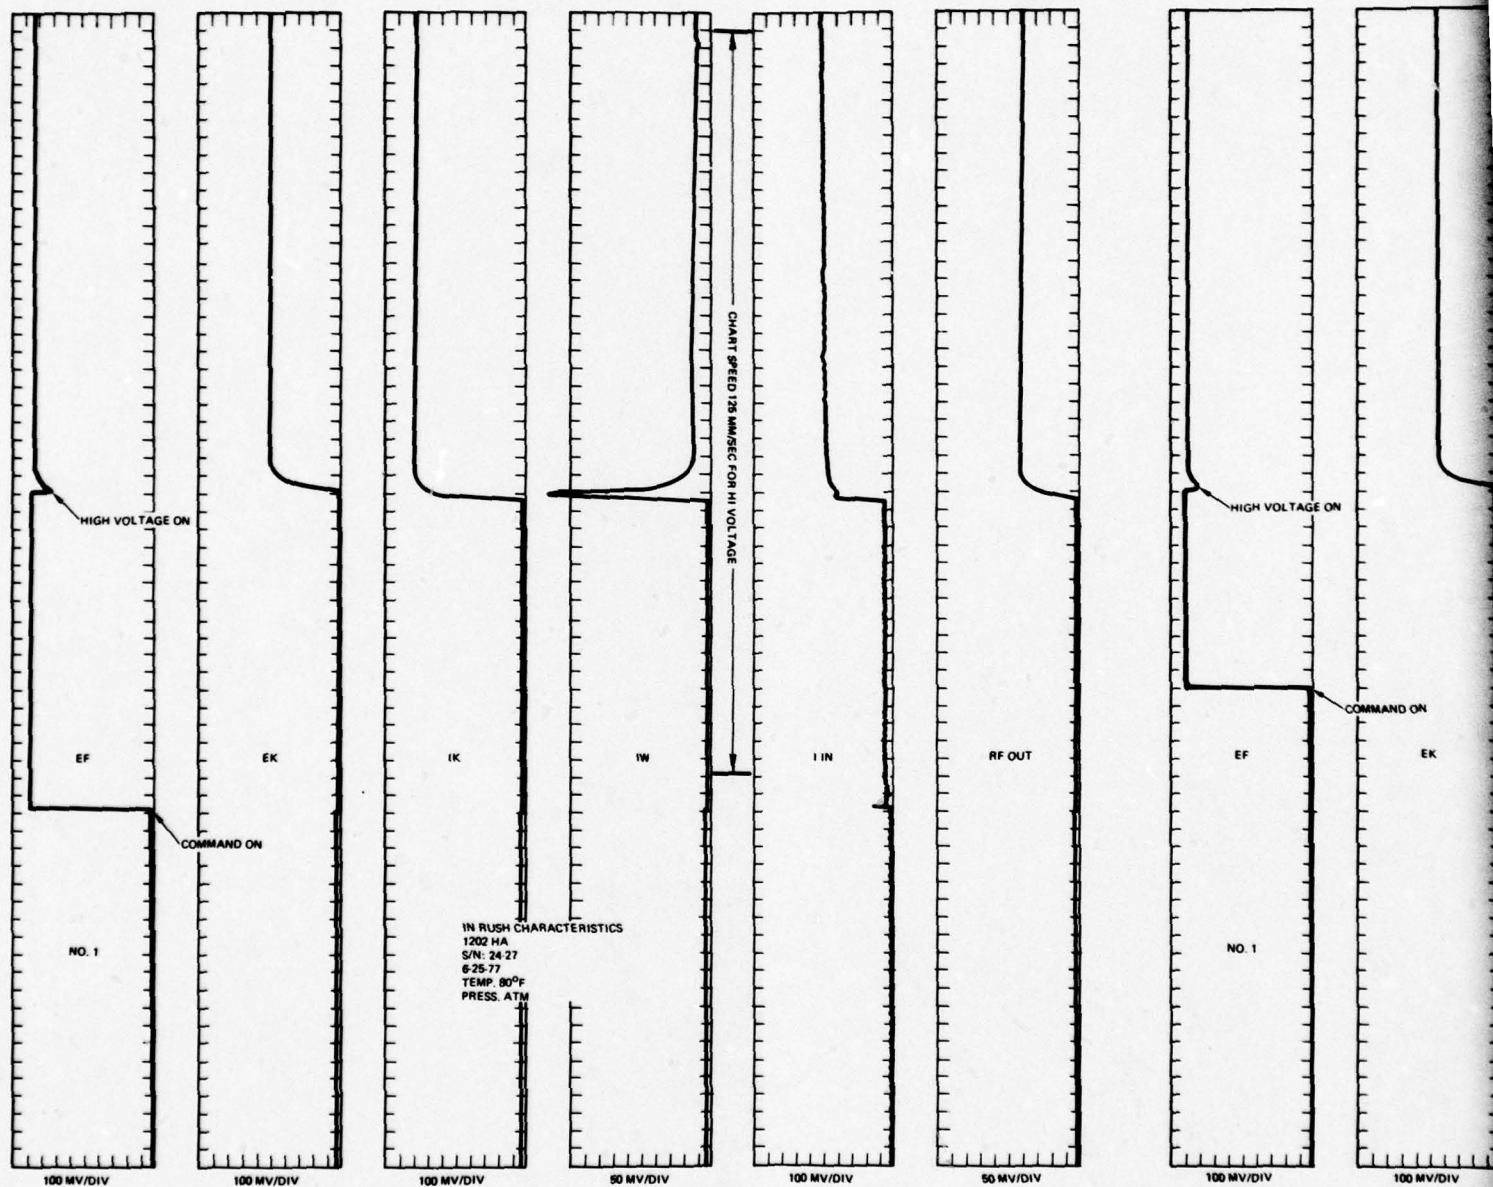
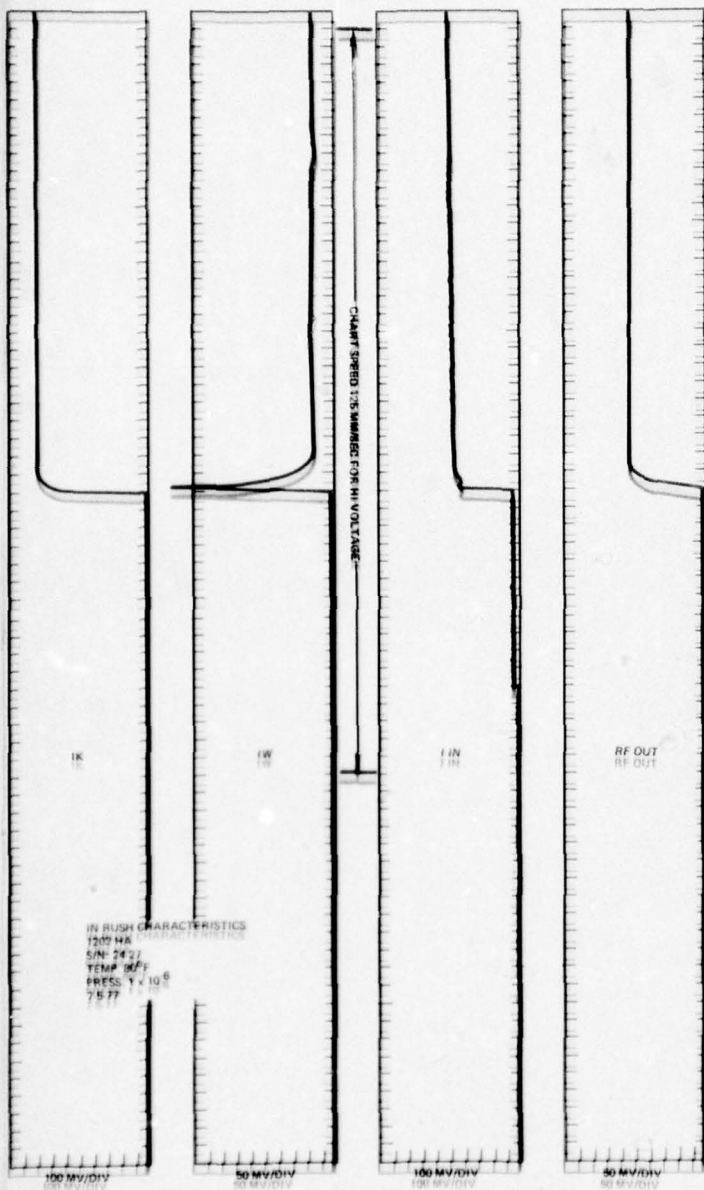
Figure 8.3-5. Turn on Characteristics for HLTWTA S/N 24-27 at Vacuum Ambient Pressure Conditions

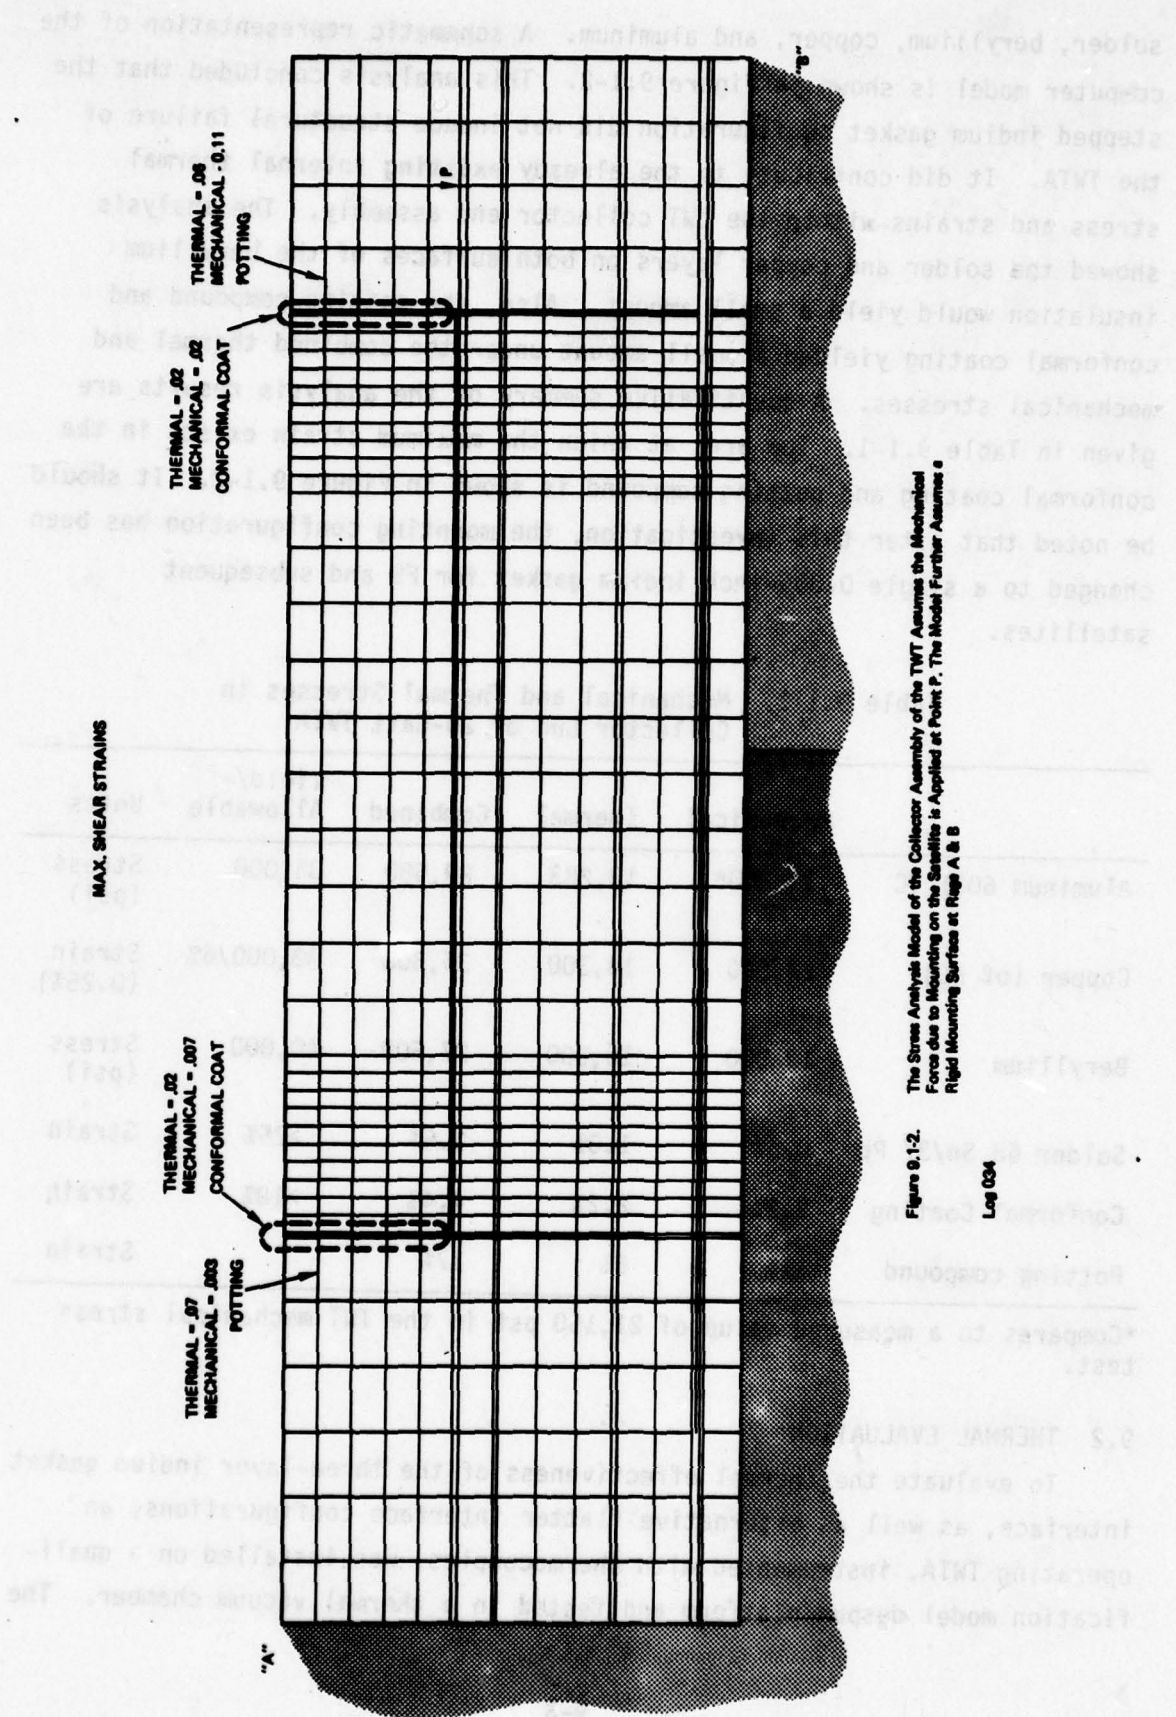
Figure 8.1-2. The Stress Analysis Model of the Collector Assembly of the TWT Assumes the Mechanical Force due to Mounting on the Satellite is Applied at Point P. The Model Further Assumes a Rigid Mounting Surface at Rigs A & B
